PHASE I REPORT  
NATIONAL DAM INSPECTION PROGRAM

Name of Dam: STOVERS LAKE DAM, NDS NO. PA-00600  
State & State No. PENNSYLVANIA, 38-5  
County: LEBANON  
Stream: A BRANCH OF BRANDYWINE CREEK  
Date of Inspection: November 15, 1978

STOVERS LAKE DAM

NDS-ID NO. PA-00600

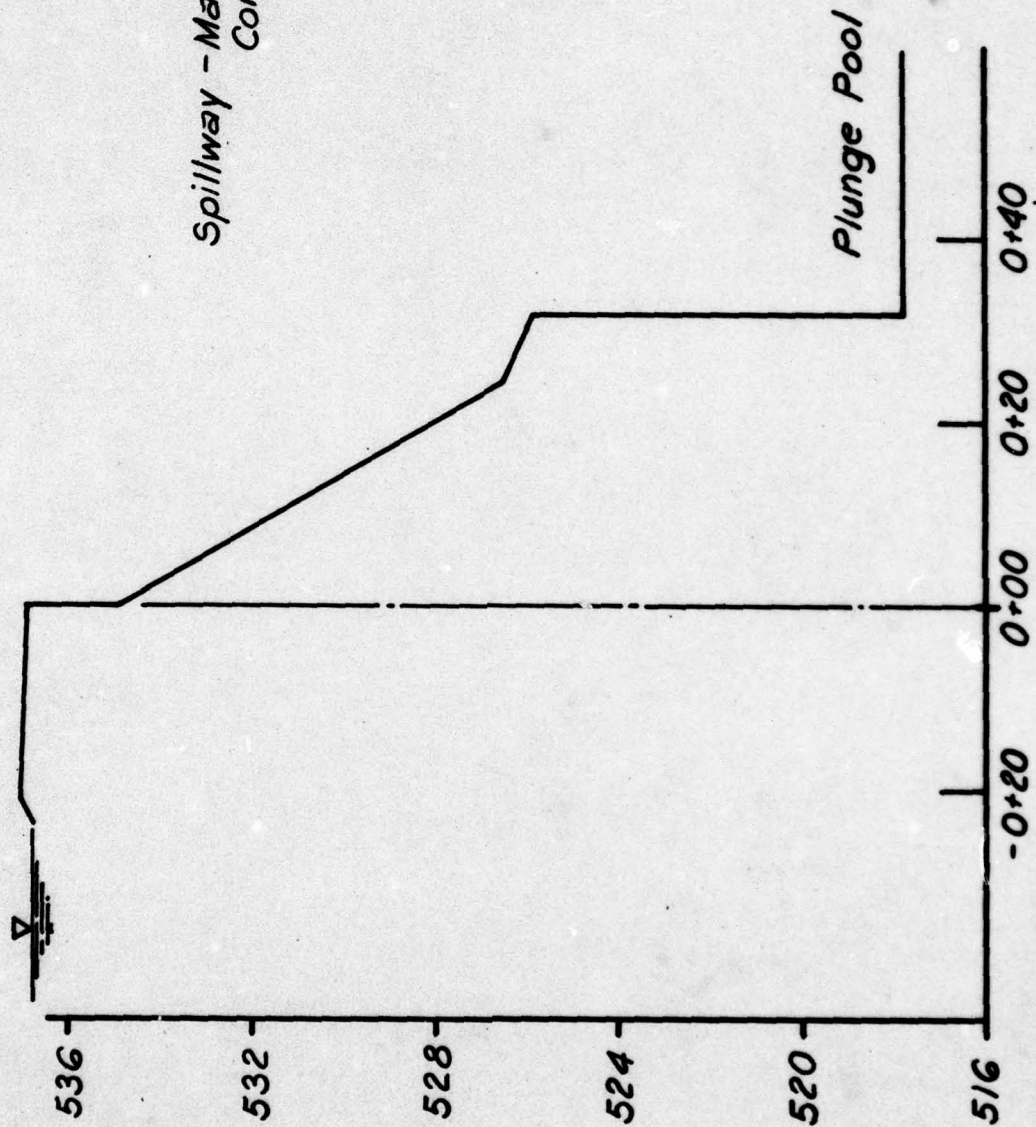
Downstream channel: The spillway chute is built of heavy, limestone masonry which has been patched with concrete. It is about 70 feet long and 18 feet wide. Starting at the crest, there is a two-foot drop (see Appendix A, Plate A-III), a 24-foot-long section with a 1V to 3H slope, an 8-foot-long section with a 1V to 12H slope, and finally an 8-foot drop to a plunge pool. Beyond the plunge pool, flow is delivered to a swampy, sluggish stream which is kept flowing by the considerable leakage from the reservoir.

Spillway - Masonry Walls with  
Concrete Flow Liner

Plunge Pool

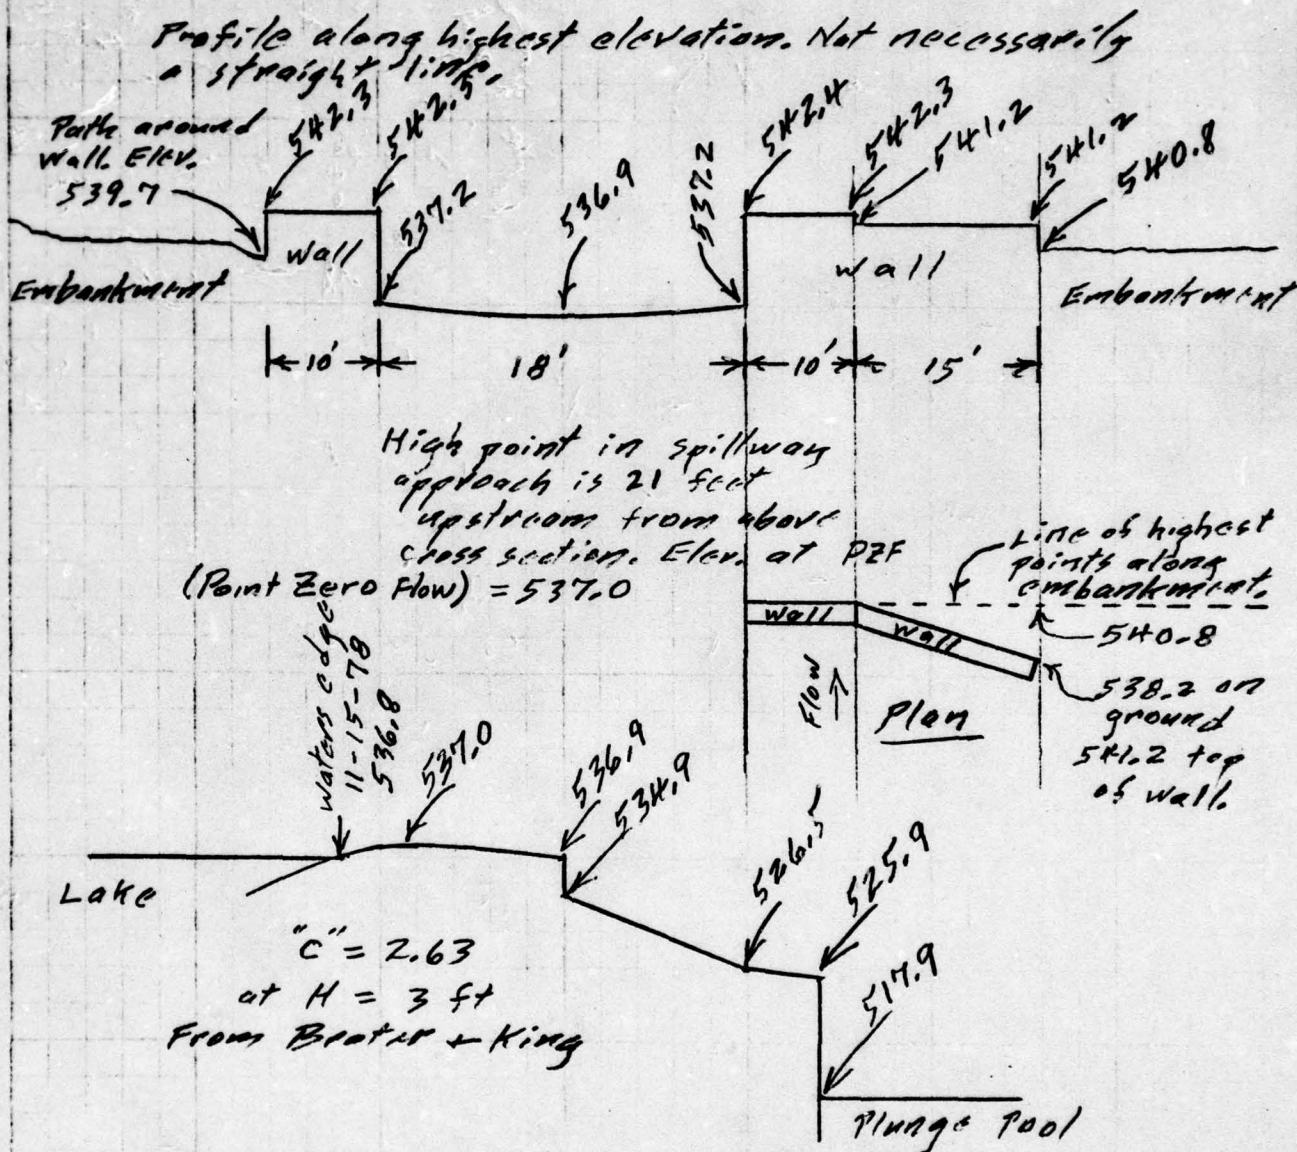
The embankment is in poor condition, due mainly to poor vertical alignment. The top of dam was designed to be three feet above the spillway. The actual average height is at present 4 feet with a low point of only about 2.7 feet above the spillway. Refer to Appendix A, Plates A-I and A-II, for the results of the survey. The dam breast has a very uneven cross section, with many gullies at the downstream and upstream edges. The top of the embankment is used by many fisherman and there is no cover. Pieces of concrete curbing are at several places. The upstream embankment slope has many bulges, probably caused by dumping riprap and cementing the surface against erosion. The lake was drawn down in 1972 and the city representative stated that the upstream slope is paved with brick over its full surface.

Top of embankment is uneven due to many paths

Lowest elev. 539.7	H = 2.7
Average elev. 541.4	H = 4.4
Highest elev. 542.3	H = 5.3
